**Remediation Assessment
130 Liberty Street Property**

**Technical Memorandum
*R3: Ductwork Remediation***

Report Date: May 2004

**Prepared for:
Deutsche Bank**

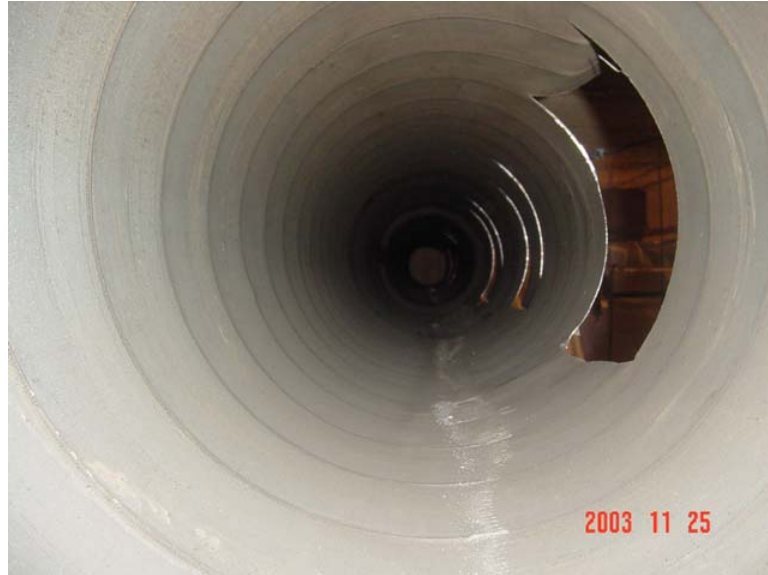
High Pressure Ductwork. High pressure ductwork investigated in this study is manufactured as a long, continuous cylinder with a spiral seam and is used for high pressure HVAC ductwork systems, shown in Figure 1. Only straight, unlined sections were investigated because these sections were deemed easiest to clean by the contractors.

Figure 1. High pressure ductwork.

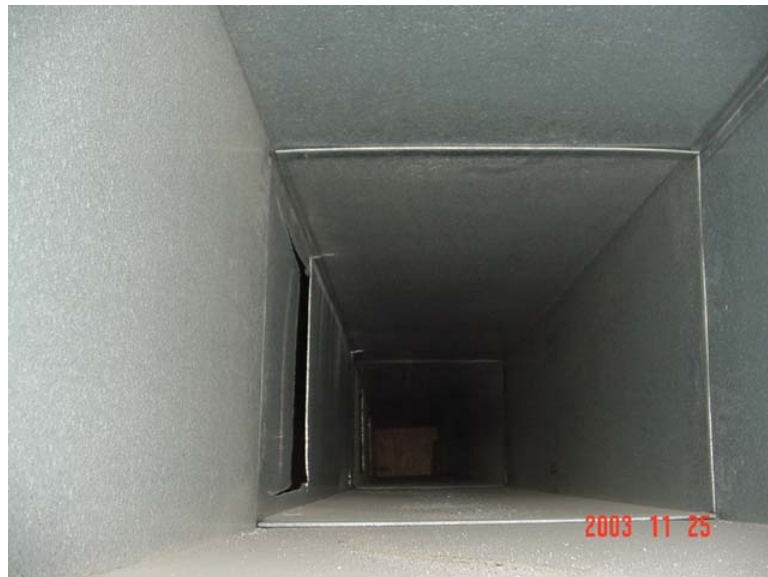
Low Pressure Ductwork. Low pressure ductwork used in this study consisted of rectangular fabricated metal ductwork that is manufactured in sections and assembled on site using a system of metal fasteners to connect the sections together (Figure 2). Only straight, unlined sections were investigated because these sections were deemed easiest to clean by the contractors.

Figure 2. Low pressure ductwork.

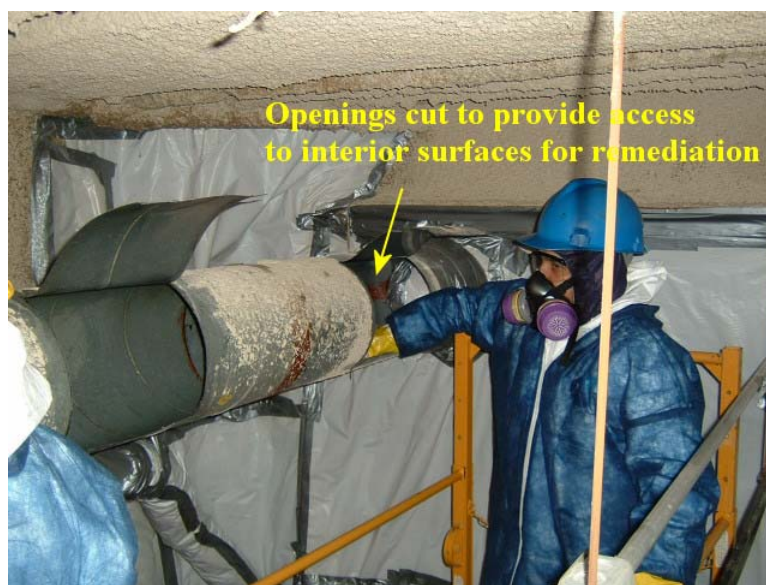
Holes were cut into the sides of the ductwork (Figure 3) every four feet to gain access to the interior surfaces (Figure 5).

Figure 3. Access to interior surfaces of high pressure ductwork.

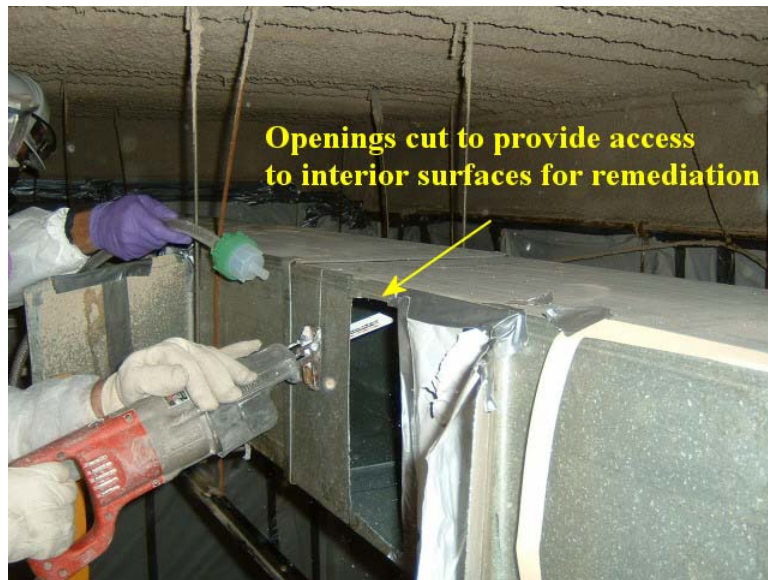
Figure 4. An opening is cut to gain access to the interior surfaces of low pressure ductwork.
