NEW YORK ENVIRONMENTAL LAW & JUSTICE PROJECT

MOLD CONTAMINATION IN 130 LIBERTY STREET

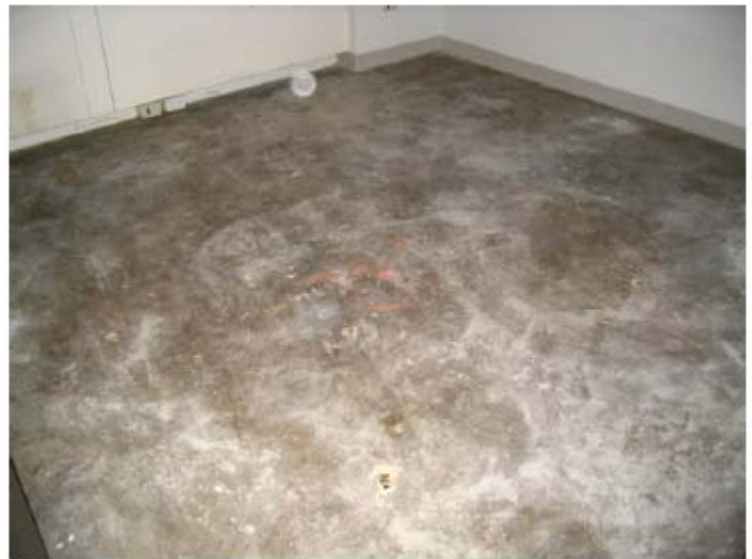
Figure 7: Floor 27 carpet water damage and visible mold (from Visual Mold Inspection Summary by TRC)
