**Damage Assessment
130 Liberty Street Property**

Report Date: December 2003

**Insurers' Testing Program
Interior Wall Cavities**

**Prepared for:
Deutsche Bank**

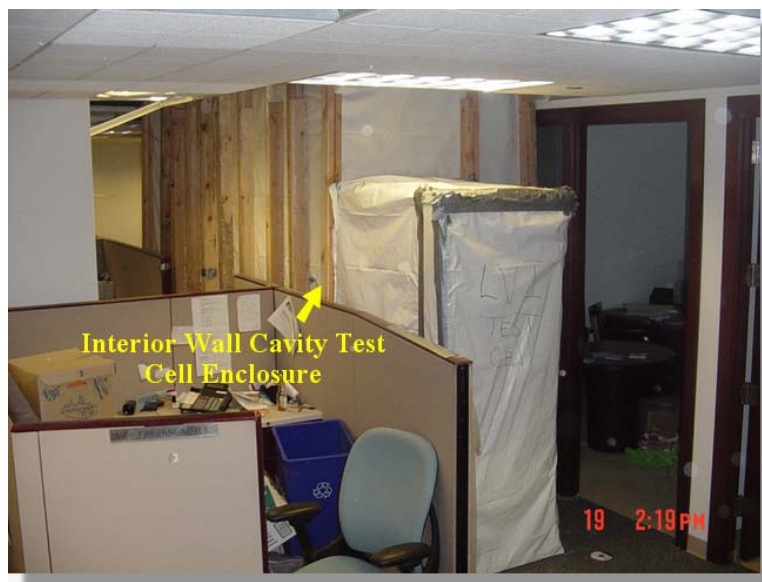
Figure 1. Example of an interior wall cavity cell

Before construction of each cell, the Insurers' representatives removed office furniture and articles that interfered with the path to the barrier walls. Cells were constructed from wooden 2"x4" frames covered with 6 mil. polyethylene and duct tape. Foam spray was used to seal all gaps and joints within the cells, and a HEPA filtered fan unit was used to maintain a positive pressure within the cell, to minimize contamination from the Building (**Figure 1**). The cells were located in various areas throughout the Building as shown in **Table 1**. The basic layout of a typical interior wall cavity cell (IWC-cell) is shown in **Figure 1**.

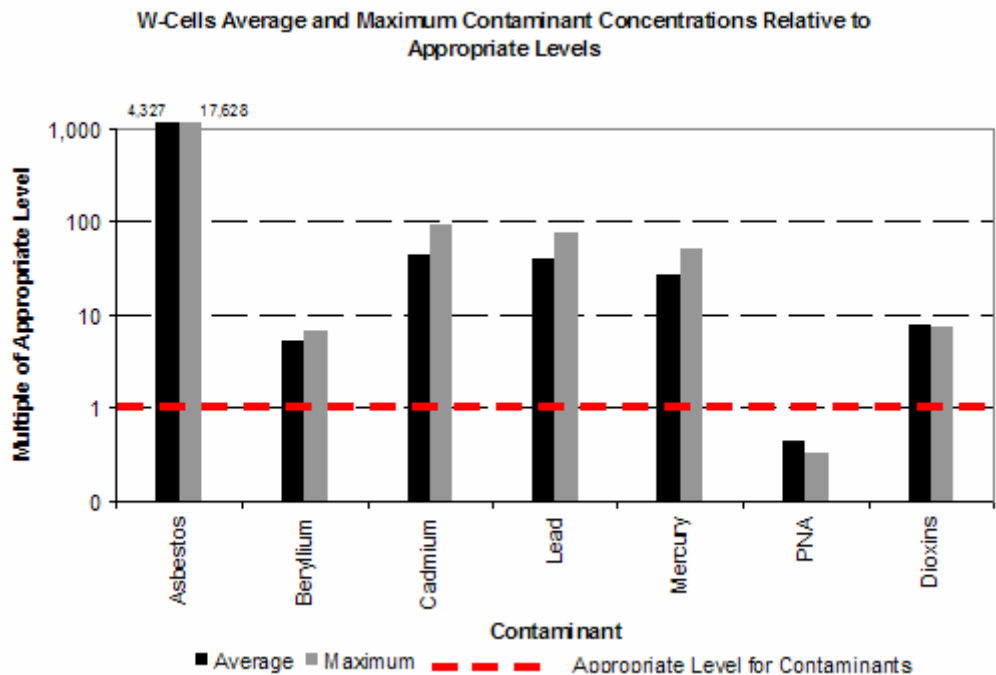
Figure 2. Comparison of WTC Dust and WTC Hazardous Substances to the Appropriate Level for Contaminants

Figure 2 shows WTC Hazardous Substances and the multiple by which the average and maximum concentrations of the WTC Hazardous Substances exceed their respective Appropriate Levels.

- WTC Dust and WTC Hazardous Substances are present in the interior wall cavities of the test cells.
- The average and maximum asbestos concentrations in the interior wall cavities of the test cells are 4,327 times and 17,628 times higher than the Average and Maximum Appropriate Level, respectively.

- The average and maximum lead concentrations are 42 times and 77 times the Average and Maximum Appropriate Level, respectively.
- The average and maximum cadmium concentrations are 43 and 92 times the Average and Maximum Appropriate Level, respectively.

- The average and maximum mercury concentrations are 26.6 and 50 times the Average and Maximum Appropriate Level, respectively.
- The average and maximum dioxins/furans concentrations are 7.8 and 7.4 times the Average and Maximum Appropriate Level, respectively.

- PNAs and PCBs were below the Average and Maximum Appropriate Level. PCBs were below the detection limits of the methods used for analysis.

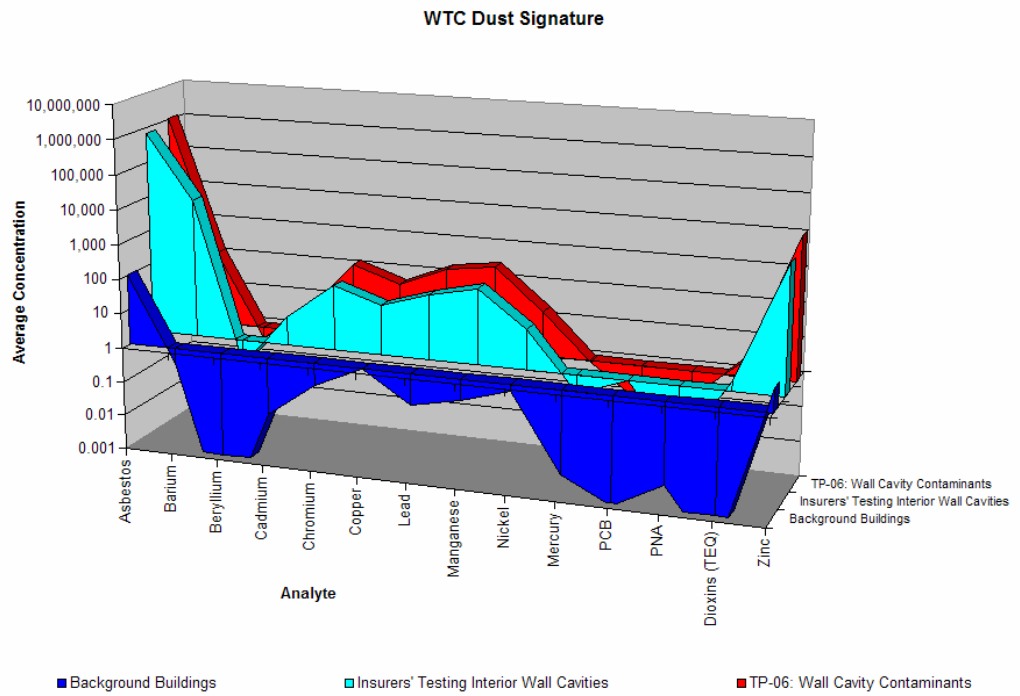
Figure 3. WTC Dust comparison of TP-06, the Insurers' interior wall cavities and Background Buildings

Figure 3 compares the WTC Dust Signature, as derived from the Interior Wall Cavities Protocol (TP-06) with the average dust compositions present within the Insurers' curtain wall cavity testing cells and within Background Buildings. There is a high correlation between CR-06 data and the testing performed within the Insurers' testing cells, indicating that the dust shares a common source, and hence, both are WTC Dust. The figure also demonstrates the substantial difference between dust from the Background Buildings unaffected by the WTC Event and the Building's interior wall cavities.

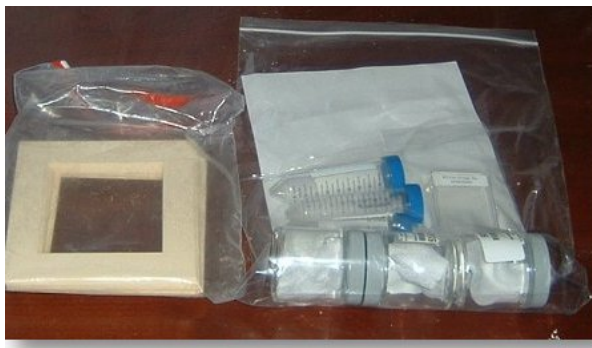
Figure 8. Sampling kit, bagged to prevent contamination

Prior to entering the Test Cells, sampling kits containing sampling media, containers, and labels were assembled (**Figure 8**).
